Job Description

- Owner:** Flaum Management
- Location:** Frontier Commons Plaza
Jefferson Road, Henrietta New York
- Type of Project:**
- Rehabilitation of pavement, including drainage repairs.
 - Existing Pavement totally failed due to poor drainage and age.

- Owner:** Bernards Grove
- Location:** Long Pond Road, Town of Greece, New York
- Type of Project:**
- Existing pavement in place recycled to create a more substantial sub-base.
 - Placed 2.5" of FoamMaster and 1.5" of Hot Asphalt Top
 - Between In-Place and FoamMaster underdrain and drainage improvements were made.

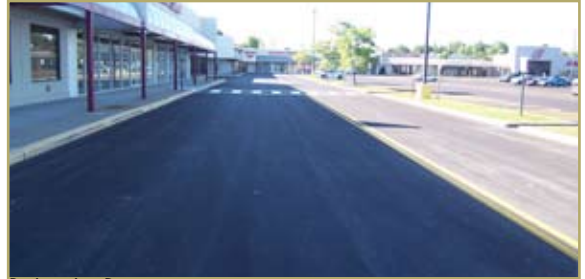
Parking Lot Drive

- Perimeter, Fire Lane, and Roadway pavement removal.
- Placed 3" Foam Asphalt Base and 1.5" Hot Asphalt Surface.
- Parking areas resurfaced with level course and 1.5" Top.

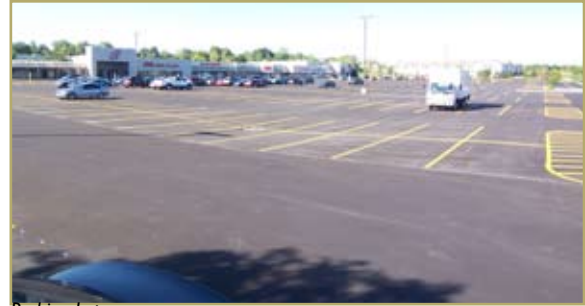
Parking Lot

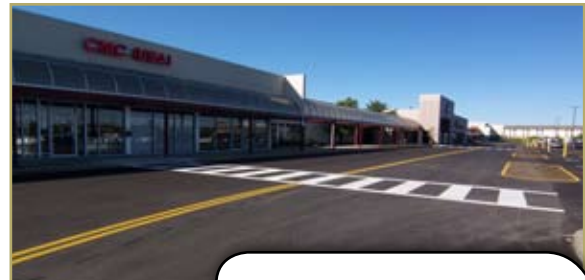
Parking Lot Drive

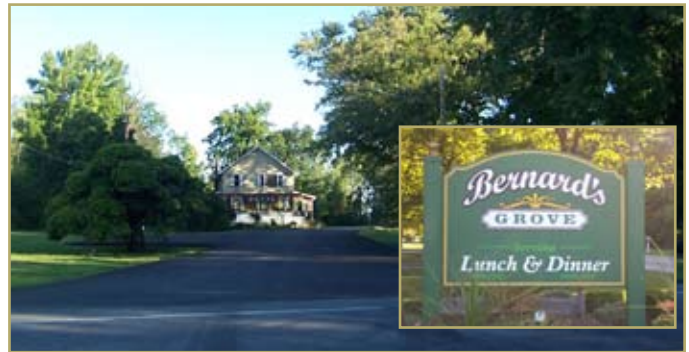
Entrance

- In-Place Recycled
- Placed 2.5" FoamMaster Foam Recycled Asphalt Base and 1.5" Hot Asphalt Surface.
- Underdrain and Drainage Improvements

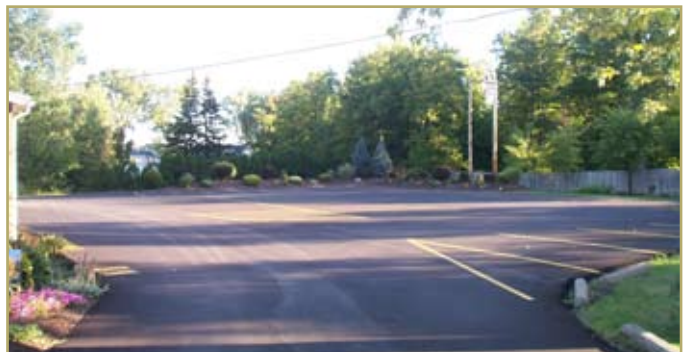
Parking Lot
